# **DBU-Project "Preventive Conservation, Securing and Safeguarding of the Cycle of Wall Paintings in the Emmaus Abbey in Prague" (AZ 38228/01)**

## **Final Report**

### **TH Köln – Technische Hochschule Köln, Cologne Institute of Conservation Sciences**

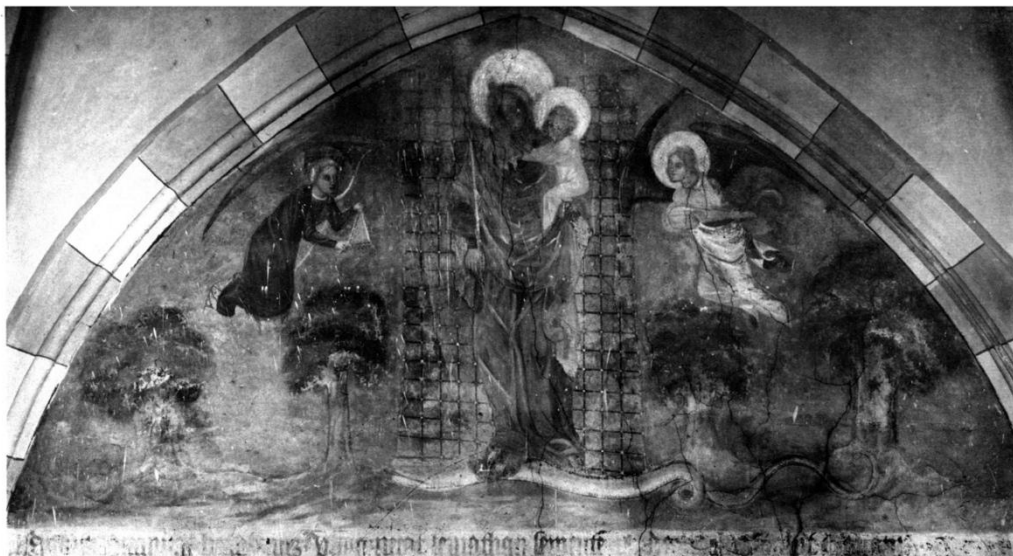
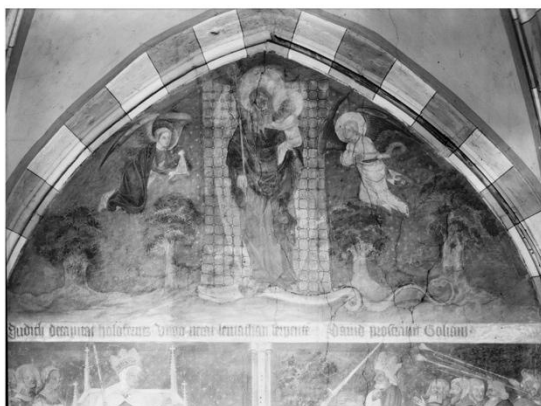
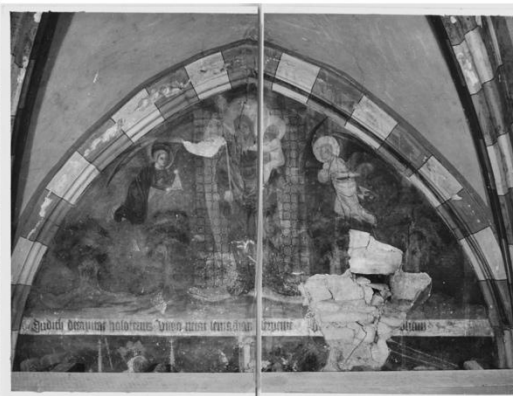
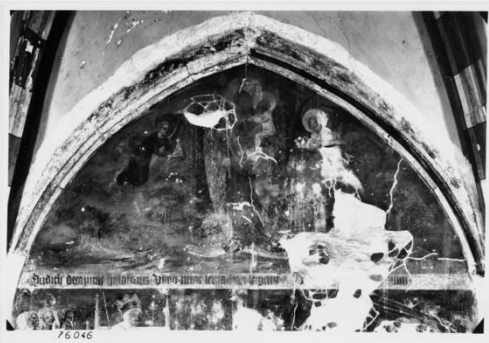
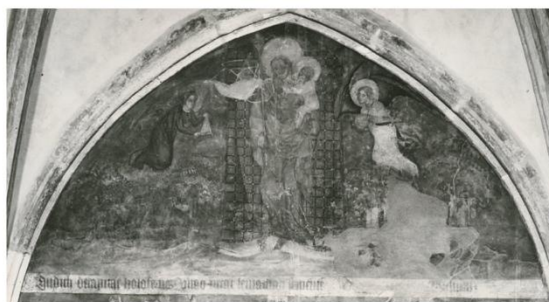
Figure 3: Field 05(05) – The Virgin Mary Wins over the Devil – chronological sequence 1898, 1935, 1945, 1957, 1968. Collage created by Kateřina Křhánková. / ©Marburg, NPÚ GR, ÚDU AV (the archives and authors of the photographs are indicated in the individual captions).

For each field, an overview of the photographic documentation across different time periods was created, making it possible to track changes in the condition of the paintings over time and to identify the effects of restoration interventions as well as other historical events. A prime example is field 05(05), for which it was possible to compile an almost continuous photographic series ranging from Bellmann's earliest photographs from before 1893, through documentation from 1935 and photographs taken after the 1945 bombing, to images capturing restoration interventions from the second half of the twentieth century. This temporal continuity represents an exceptionally valuable source for assessing changes in the appearance and condition of the paintings over the course of more than a century. The examples are shown in the figures below (Figure 3, Figure 4, Figure 5, Figure 6).

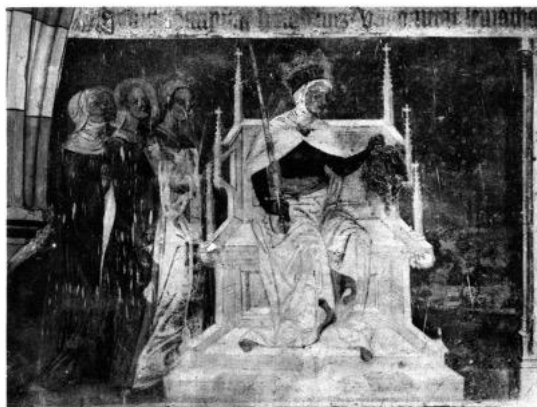
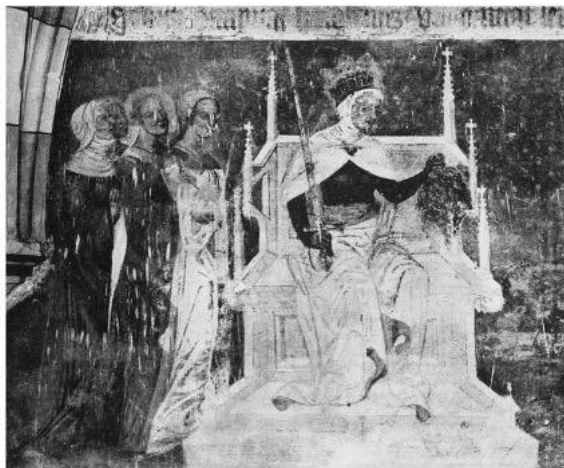
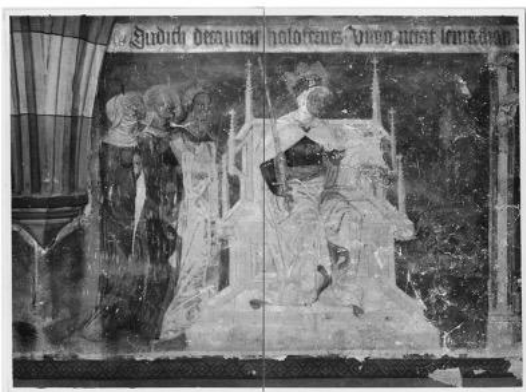
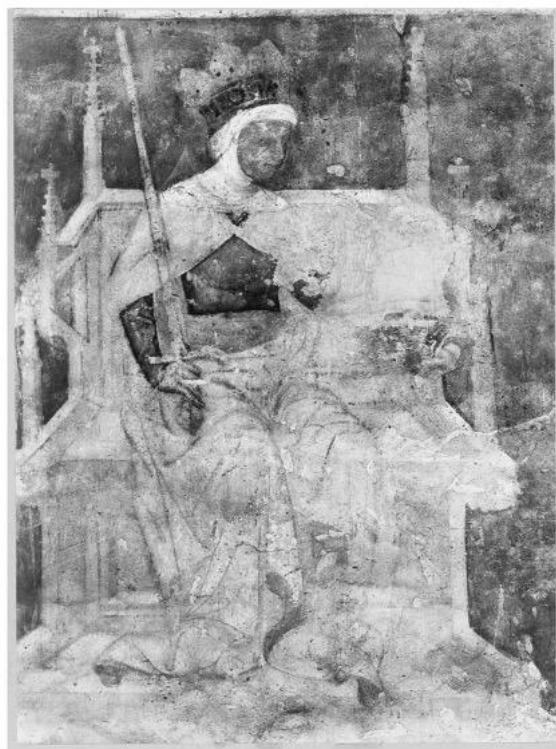
Figure 4: Field 05(05) – Judith with the Head of Holofernes – chronological sequence 1898, 1935, 1945, 1957, 1968. Collage created by Kateřina Krhánková. / ©Marburg, NPÚ GR, ÚDU AV (the archives and authors of the photographs are indicated in the individual captions).

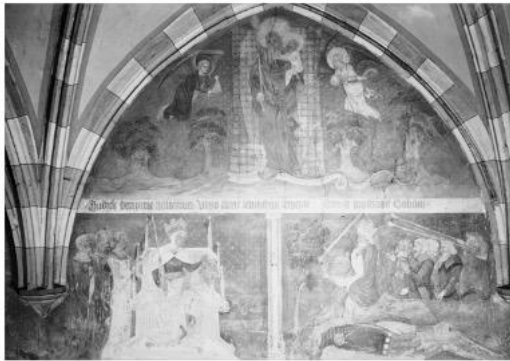
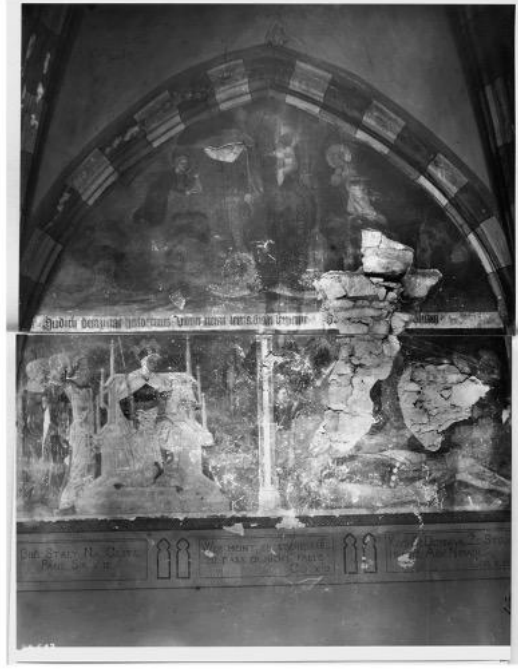
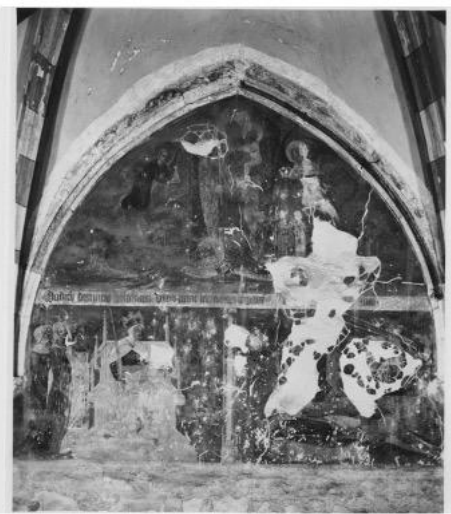
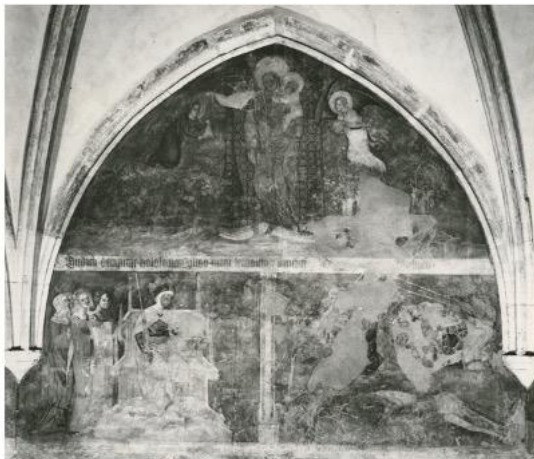
Figure 5: Field 05(05) – The Virgin Mary Wins over the Devil; Judith with the Head of Holofernes; David with the Head of Goliath – chronological sequence 1935, 1945, 1957, 1964, 1968. Collage created by Kateřina Krhánková. / ©Marburg, NPÚ GR, ÚDU AV (the archives and authors of the photographs are indicated in the individual captions).

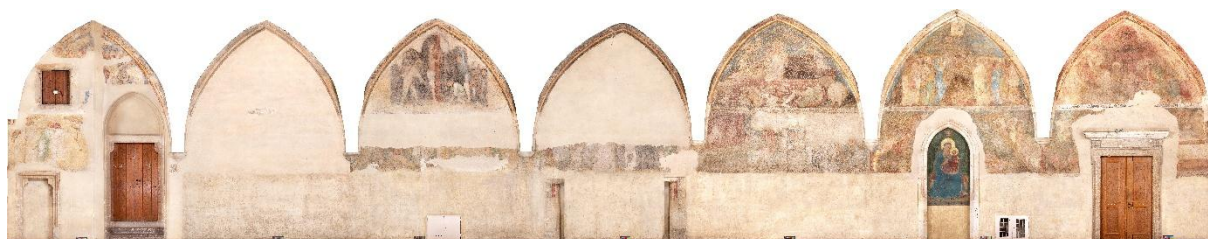
Figure 7: Photogrammetric image of the East walk of the cloister. © Jiří Vidman, Pavel Hlavenka.

Work Package 3 realized by UPCE team in collaboration with ABK included a thorough inspection of the paintings from mobile scaffolding. Photogrammetry was produced by external collaborator Ing. Jiří Vidman for all twenty-six individual bays (Figure 9) as well as the four walls of the cloister (Figure 7, Figure 8) at various resolutions, including shaded relief models (Figure 10). Detailed photographic documentation of individual details was acquired. Furthermore, phenomena related to the original, added and altered materials, the condition of the paintings, and those requiring further intervention or monitoring were described and catalogued. Graphic mappings were carried out to document selected categories of both the original technique and phenomena associated with the state of preservation and potential risks, which also enabled the quantification of the monitored categories and the subsequent calculation of the extent of the preserved original parts of the paintings. The on-site work and subsequent processing spanned the first four monitoring periods and included two student campaigns with UPCE students, one during the second and other during the fourth monitoring period (autumn 2023 and autumn 2024).

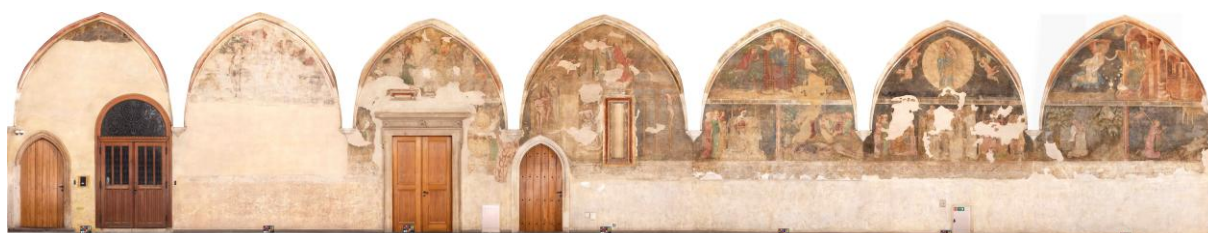
Figure 8: Photogrammetric image of the South walk of the cloister. © Jiří Vidman, Pavel Hlavenka.

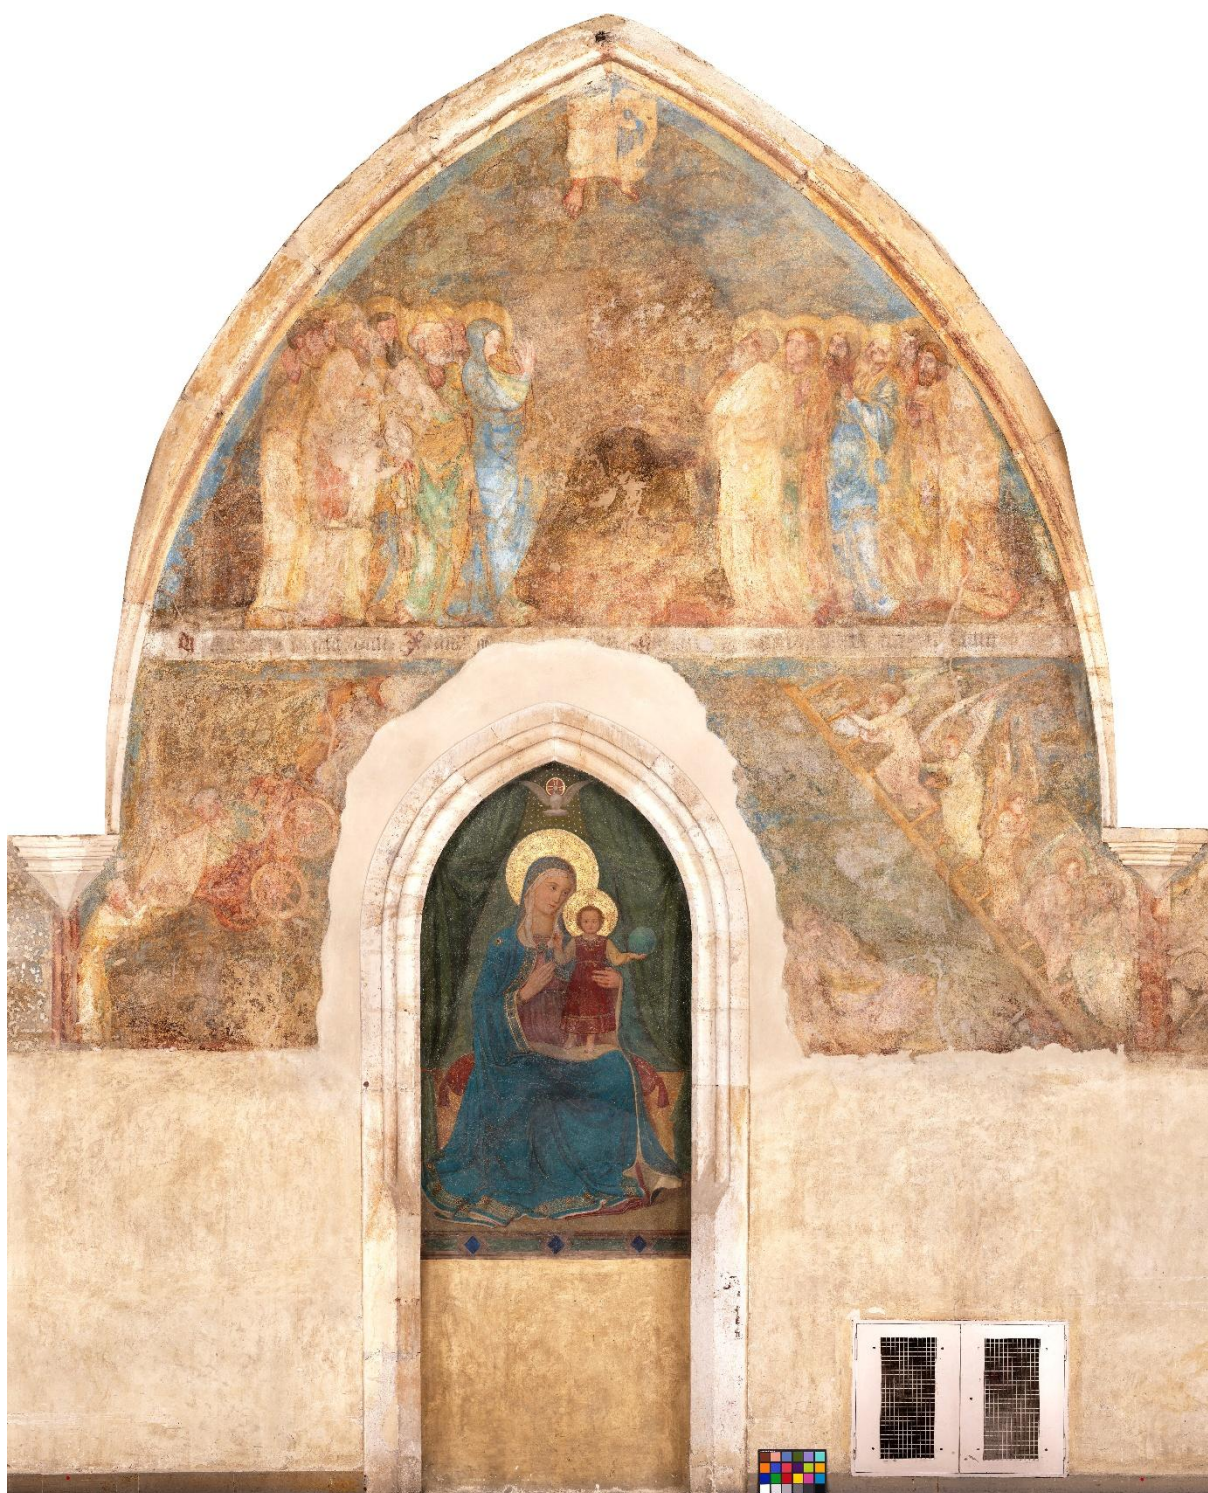
Figure 9: Photogrammetric image, orthophoto, bay 25 (32). © Jiří Vidman, Pavel Hlavenka.

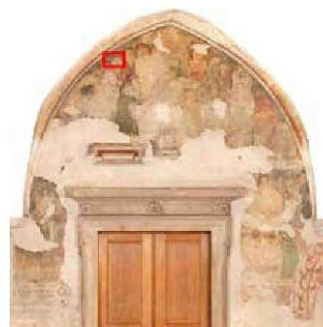
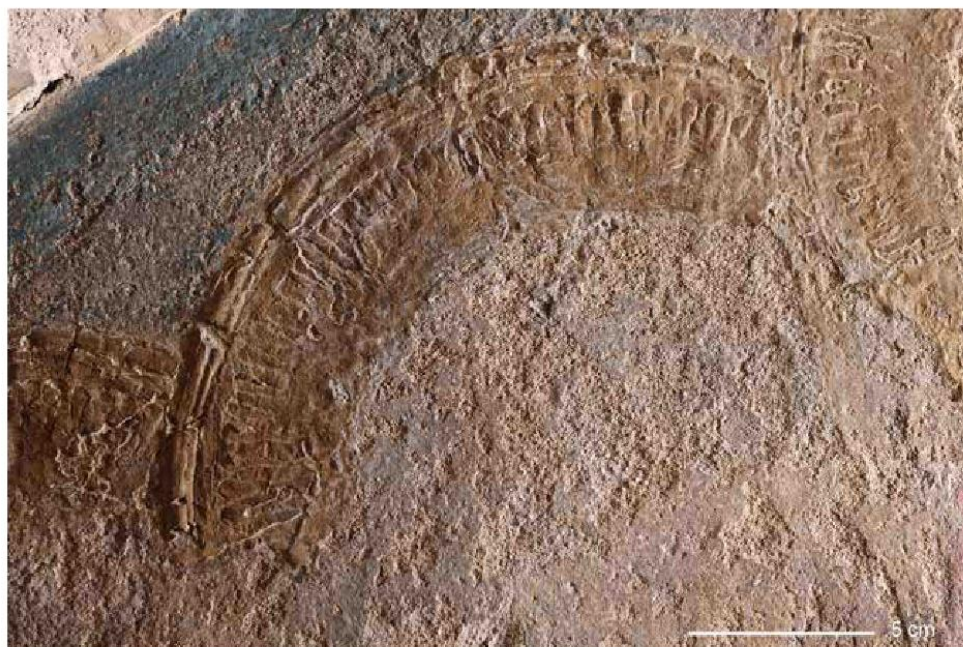
**Number:** A35  
**Code:** 071  
**Location:** South walk, bay 3 (3)  
**Mapping:** Yes

Relief decoration is preserved only in the haloes of certain figures in the Last Supper scene (bay 3 (3)) and in the haloes and parts of the angels' wings in bay 1 (1) (example A). Each individual halo consists of several sections. The tin relief technique has been confirmed by laboratory analysis. Traces of gilding are visible on the relief layer, although the gilding is better preserved in its surroundings. A faint imprint of the relief decoration is visible in the Virgin Mary's halo in bay 7 (7) and in the Christ Child's halo in bay 6 (6) (example B).

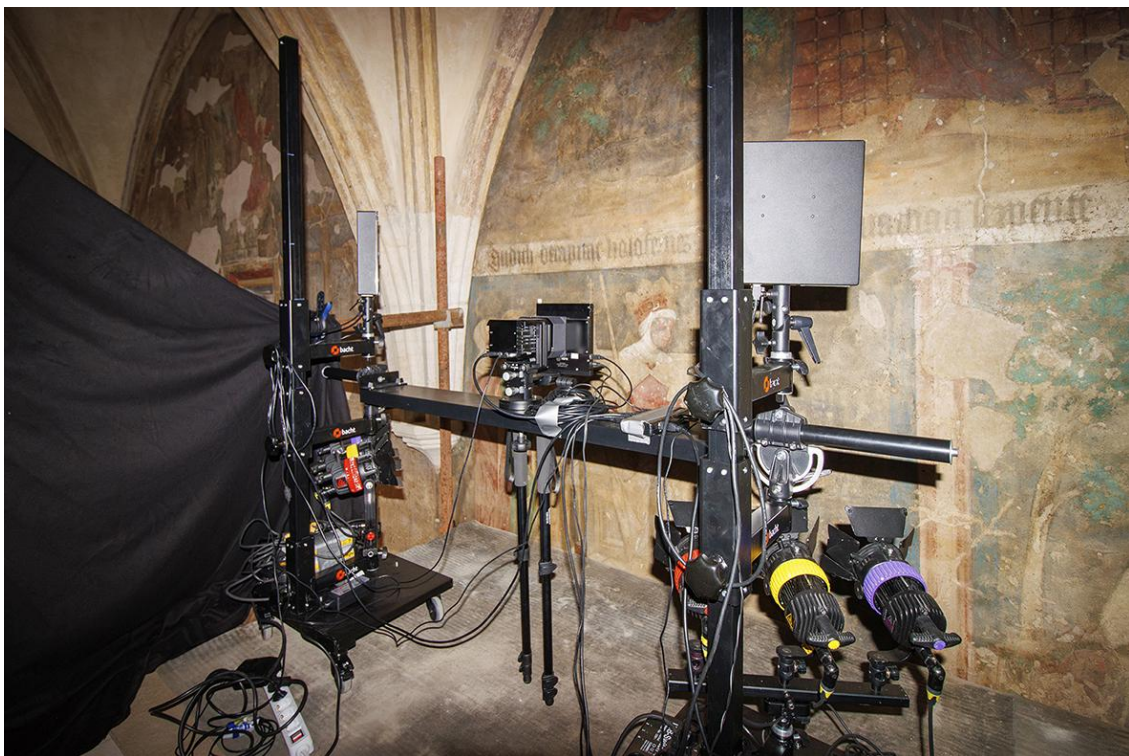
Figure 25: The Rainbow System from the back on scaffold ©David Svoboda.

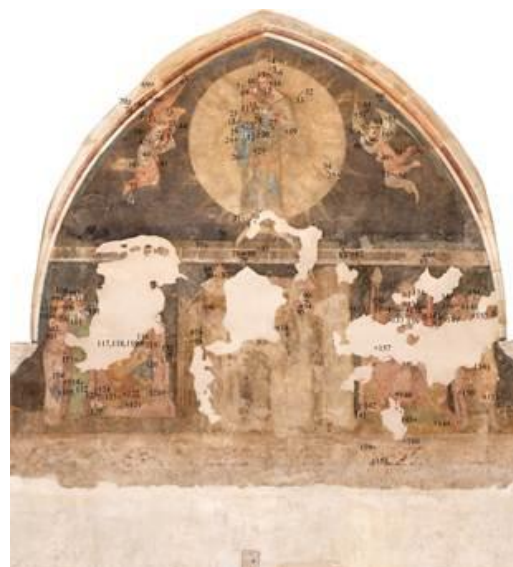
Figure 32: Example of the strategy of pXRF measurements on bay 6(6). Photogrammetric image © Jiří Vidman, Pavel Hlavenka.

The survey aimed to identify the principal pigments and gilding materials, evaluate their distribution within the broader number of scenes including scenes of main interest, and provide a systematic elemental dataset supporting the interpretation of complementary invasive and non-invasive analyses. An example of the measurement strategy and evaluation shows (Figure 31, Figure 32).

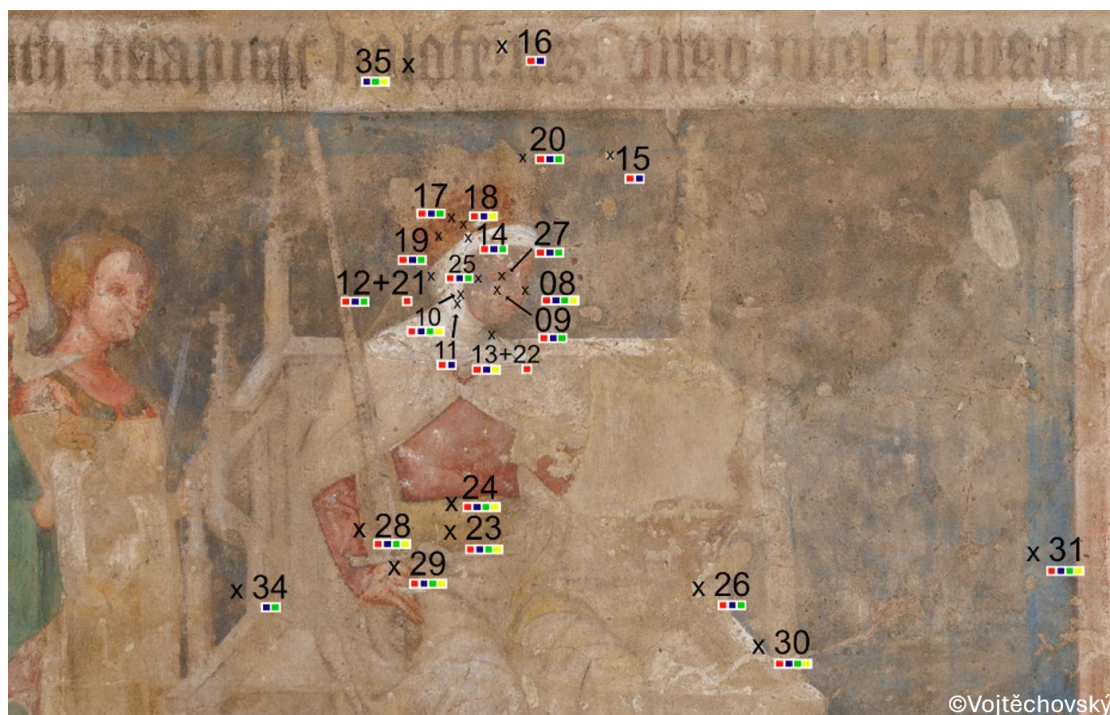
Figure 34: Bay 5 (5) overview of the measurement points and the combination of measurement methods (red: pNIR; blue: pRaman; green: pXRF by J. Zöldföldi; yellow: pXRF by P. Lesniaková), (2023 image basis ©Jan Vojtěchovský, 2026 image editing ©Katharina Schellbach)

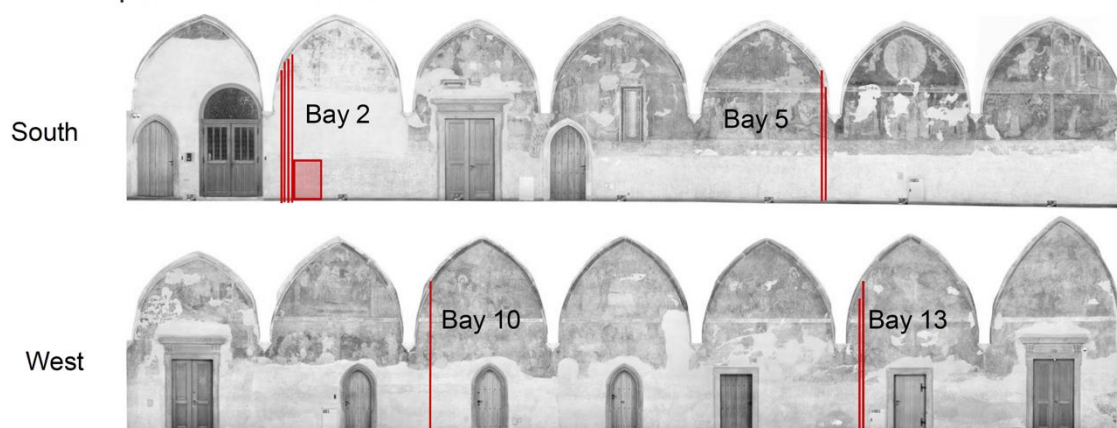
Figure 44: Red lines show hot water pipes/radiators of today's heating system in adjacent rooms/backside of the wall paintings. Orthophotography © Jiří Vidman, Pavel Hlavenka. (Modified by Rebecca Tehrani)

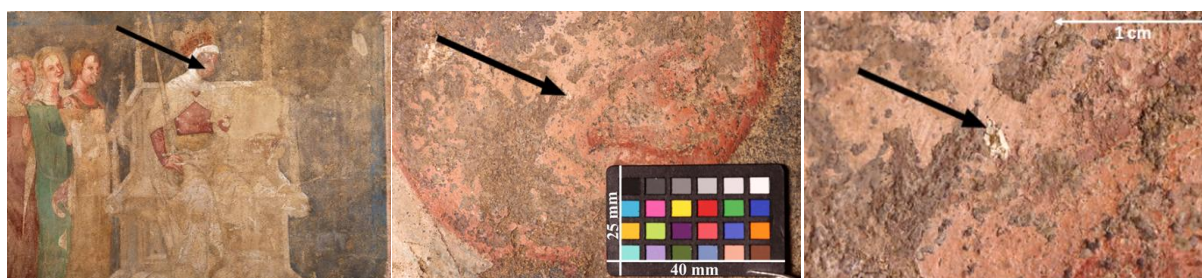
Figure 63: Photographic documentation and localisation of sampling: Judith's face, scene Judith with the Head of Holofernes, Bay 5(5), from the left: location of sampling pointed in a photogrammetric image (©Jiří Vidman); detail with a reference colour chart which also serves as a scale (©Vojtěchovský, Jakubů, Lesniaková); macrophotography with a scale (©Jan Vojtěchovský, Daniela Jakubů, Petra Lesniaková).
